Arlington High School Building Committee

MEMORANDUM

re: Geothermal Wells

Date: March 20, 2020
Recipient: HMFH Architects
Copy To: Ms. Lori Cowles and Mr. Arthur Duffy
Sender: William J. Burns, L.S.P. and Jonathan W. Patch, P.E.
Project: Arlington High School
Project No: 6531.2.TB
Subject: Evaluation of Geothermal Well Field Options 1 through 4

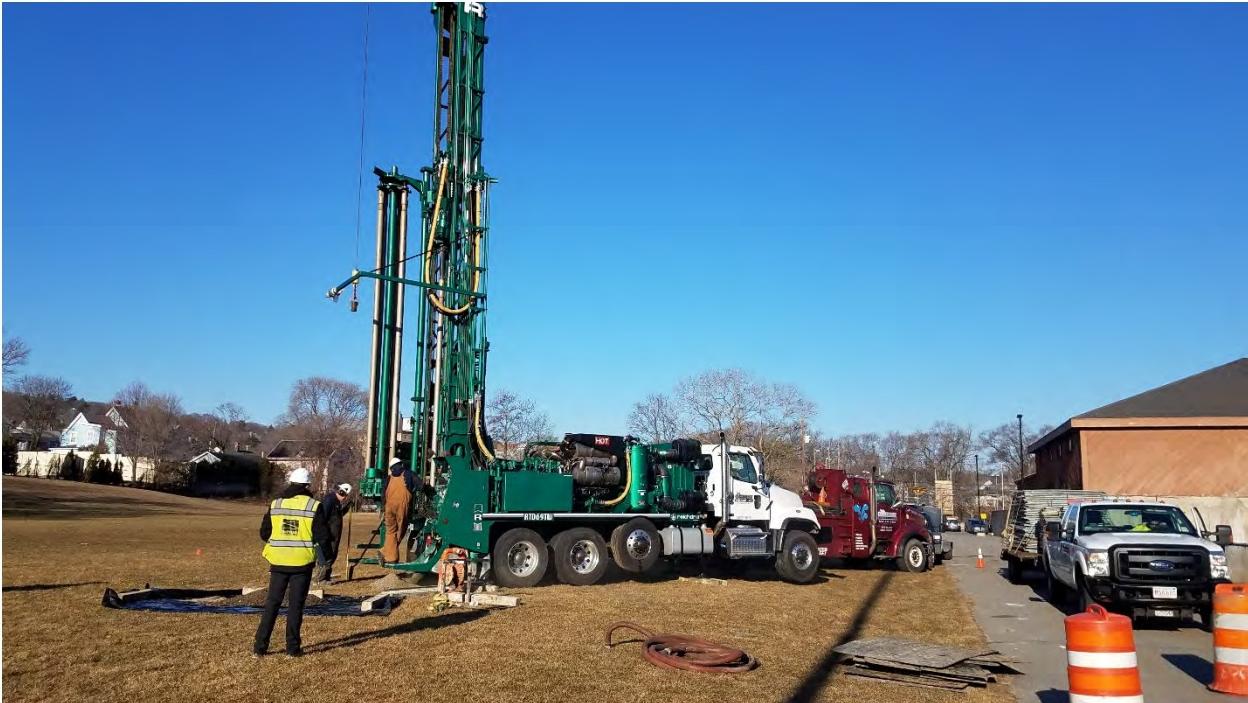
At the start of drilling operations, Ogden encountered a layer of granular fill material the thickness of which could not be accurately measured during the advancement of drilling. However, at a depth of 25 to 30 feet below ground surface it was visually apparent that the drilling had extended into a natural, glacial outwash deposit. At approximately 50 feet below ground surface, the driller encountered a running sand deposit that clogged the drill bit and hindered the air return of the drill rig. After removing the rods, the driller utilized a Takeuchi TB235 mini-excavator to dig a sump pit for capturing slurry that was subsequently introduced into the drilling operation. This slurry consisted of bentonite powder and water. The sump pit consisted of a 2 to 3-foot deep hole which was located adjacent to the test borehole. The upper 2 feet of soil were stockpiled for later use as backfill material, whereas all soil below this depth was required to be placed on a polyethene sheet and later placed in a roll-off container set to be delivered tomorrow.
